TOWERCRAFT INSPECTION REPORT

Comprehensive Building Façade Condition and Risk Assessment Report

Report Number	TC-INS-[2025]-[2]
Date	[11-12/10/2025]
Building Name	XXXXX
Location	DUBAI
Customer / Company	XXXXX
Inspection Team	XXXXX
Prepared By	Towercraft Inspection
Weather	36-41 °C
Humidity (%)	%57

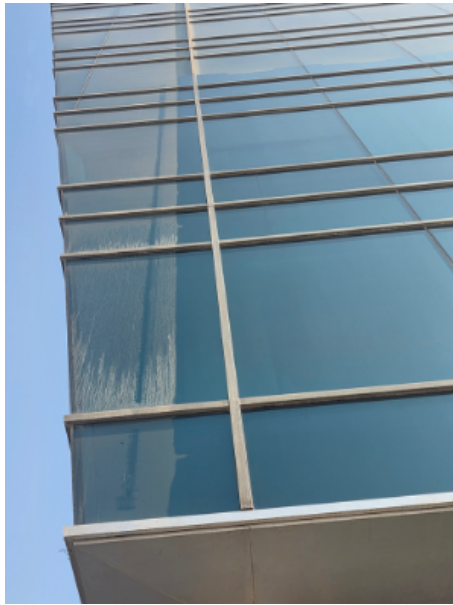
Area	No	Before Dry Clean	After Deep Clean	Description	Contamination Type
North West Facade	Image M1

Dust and mud layer detergent residues	T1-D1

Heavy accumulation of dirt, chemical residues, minerals, and environmental particles has been detected. Dubai's high temperature and intense UV radiation cause these chemical residues to penetrate the glass surface rapidly, significantly increasing the risk of permanent dullness and chemical damage, while severely reducing light transmittance.

Dry Clean: Most of the dust and mud particles have been removed; however, at the microscopic level, thin film layers and micro-residues are still observed. This indicates that mineral stains have penetrated the glass pores due to rapid evaporation of dirty water at high temperatures, leaving the glass looking dull and stained.

Area	Identified Issue	Relevant Microscope No	Risk Level	Recommended Action
North West Façade	Dust & Mud Layer Detergent Residues	M1	Medium	Enzyme-based cleaning with UV sterilization
North West Façade	Oxidation and Colour Fading on Aluminium Surfaces	M3	High	Enzyme-based cleaning with UV sterilization
North West Façade	Premature Aging and Colour Change (Yellowing/Dulling) in Expansion Joints	M3	Medium	Chemical sealer and soft washing

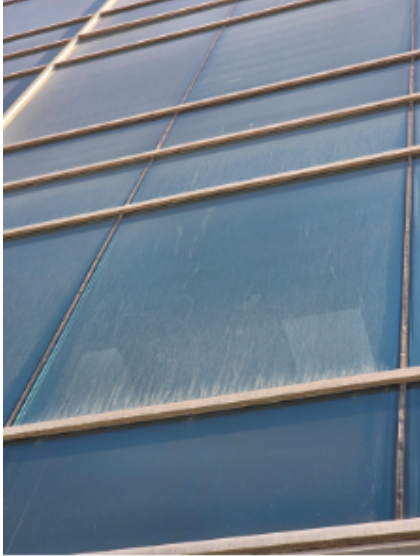
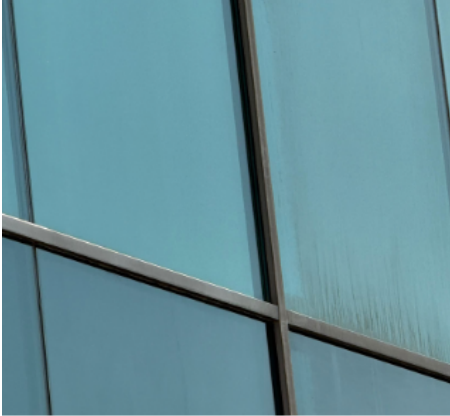
<p>North West Facade</p>	<p>Image M2</p>

<p>Oxidation and Colour Fading on Aluminium Surfaces</p>	<p>ALOX1</p>
<p>North West Facade</p>	<p>Image M3</p>

The surface showed heavy dust, mineral, and lime stains (whitish, irregular spots) with an overall matte and rough appearance. Dubai's hard water and low humidity cause rinse water to evaporate rapidly, making lime deposits permanent and weakening the aluminium's protective oxide layer, leading to dullness and oxidation over time.

Dry Clean: Although surface contamination was reduced overall, non-uniform linear stains (thin film layers caused by water and mineral deposits) remained. The surface appeared dull and streaked.

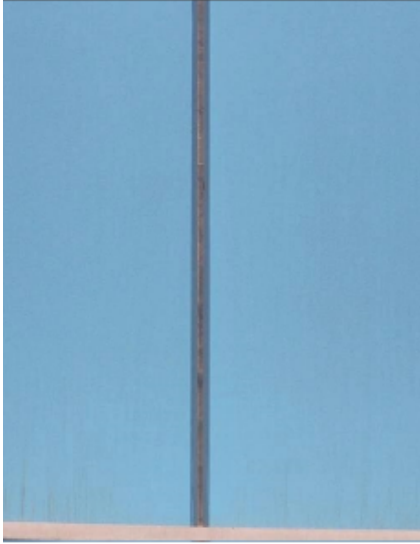
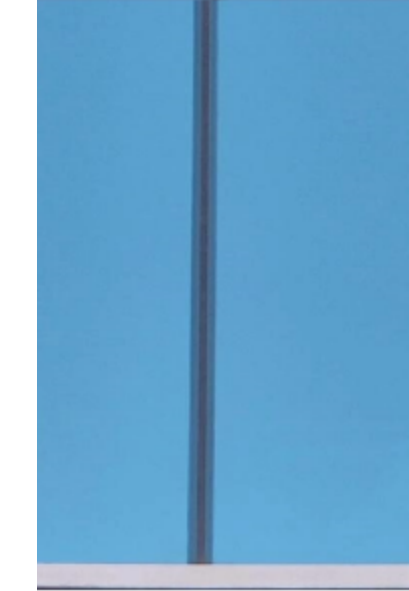
<p>Premature Aging and Colour Change (Yellowing/Dulling) in Expansion Joints</p>	<p>GD1MT-CC2</p>

A heavy accumulation of dust, dirt, and particles was observed on the gasket surface. Dubai's persistently high UV radiation and temperature levels cause premature aging of the gasket's base material (typically silicone or polyurethane), while the dust and mineral buildup on the surface accelerates this process—reducing flexibility and increasing the risk of compromised sealing performance.

Dry Clean: Most of the coarse dirt on the gasket surface was removed. However, fine mineral residues and adhered particles remained; the gasket still appeared matte and rough.

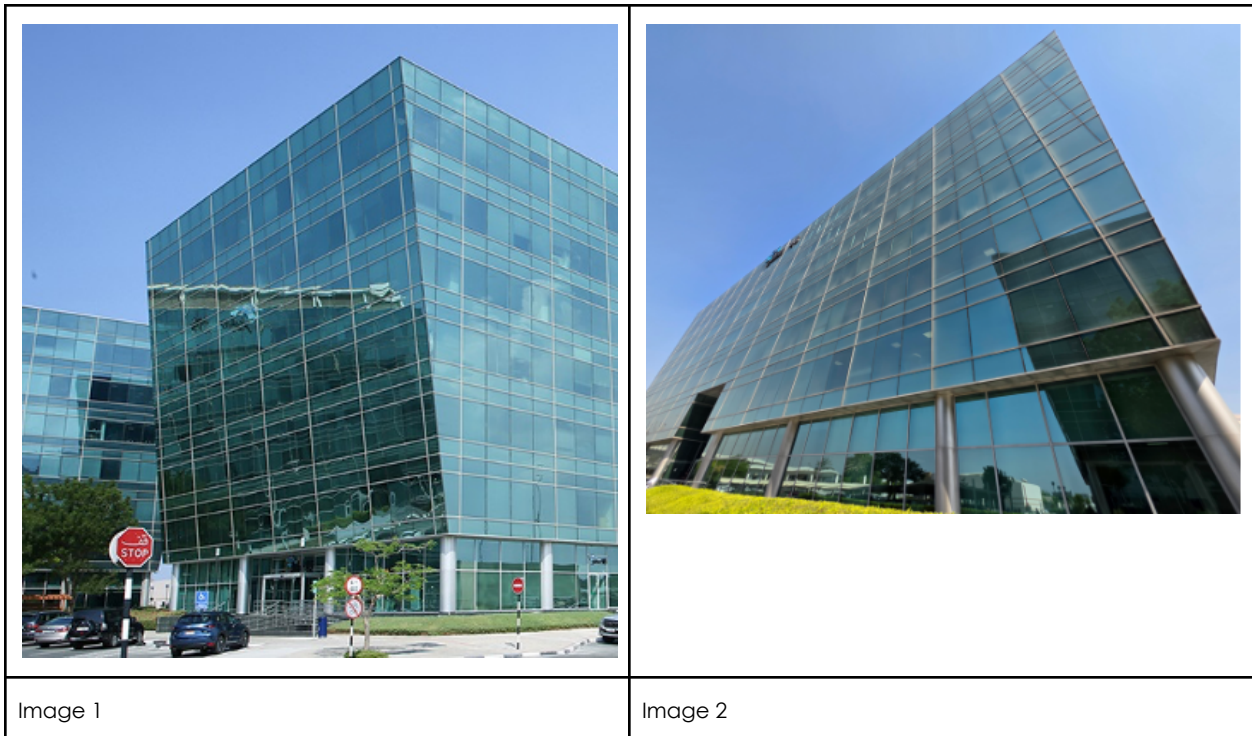
The building's east and west façades have an inward (negatively inclined) design (Image-1), which prevents effective operation of the Towercraft Robot due to standard façade access limitations. Additionally, the glass area at the building's entrance cannot be reached because of the elevation difference (Image-2).

Due to Towercraft Robot's limited ability to clean negatively inclined surfaces, rope access teams may be used for these areas. However, manual interventions must be conducted with extreme care, ensuring surfaces are thoroughly rinsed to eliminate harmful chemical effects.

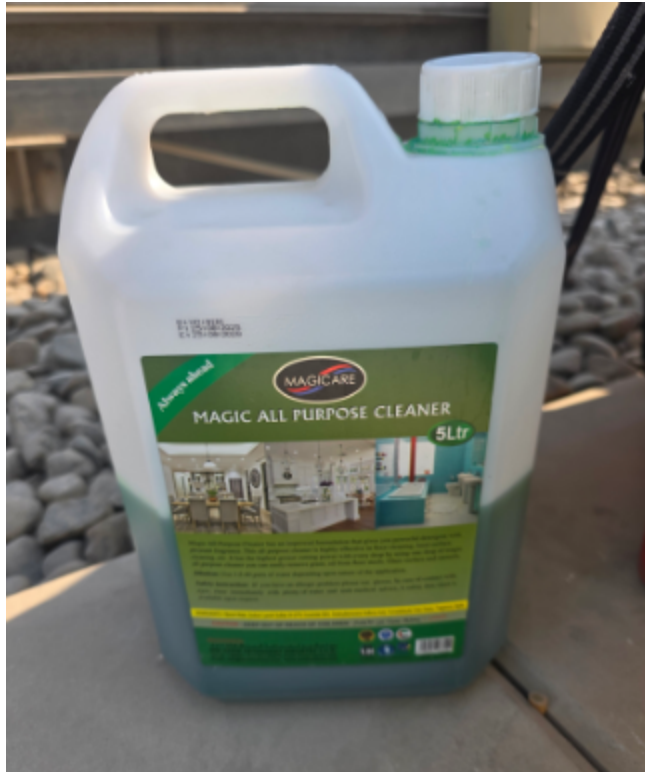
The detergents and chemical mixtures used were not specifically formulated for glass surfaces but were instead general-purpose ("all-purpose") cleaning products. When not properly rinsed, such products leave a chemical film layer on the glass, reducing optical clarity. This layer affects the glass's transparency and brightness. Over time, it causes **dullness and shadowing** on the glass. Dust and sand particles adhere to this layer, forming a "**film dirt**" coating. Under UV exposure, this layer **changes colour or turns yellowish**.

The alkaline components and perfume solvents contained in the detergent can **dull the anodised layer**. Prolonged contact may cause **pigment fading or chalking effects** on the paint layer. It was also determined that failure to clean around surface obstacles and insufficient rinsing resulted in colour changes and permanent surface deterioration.

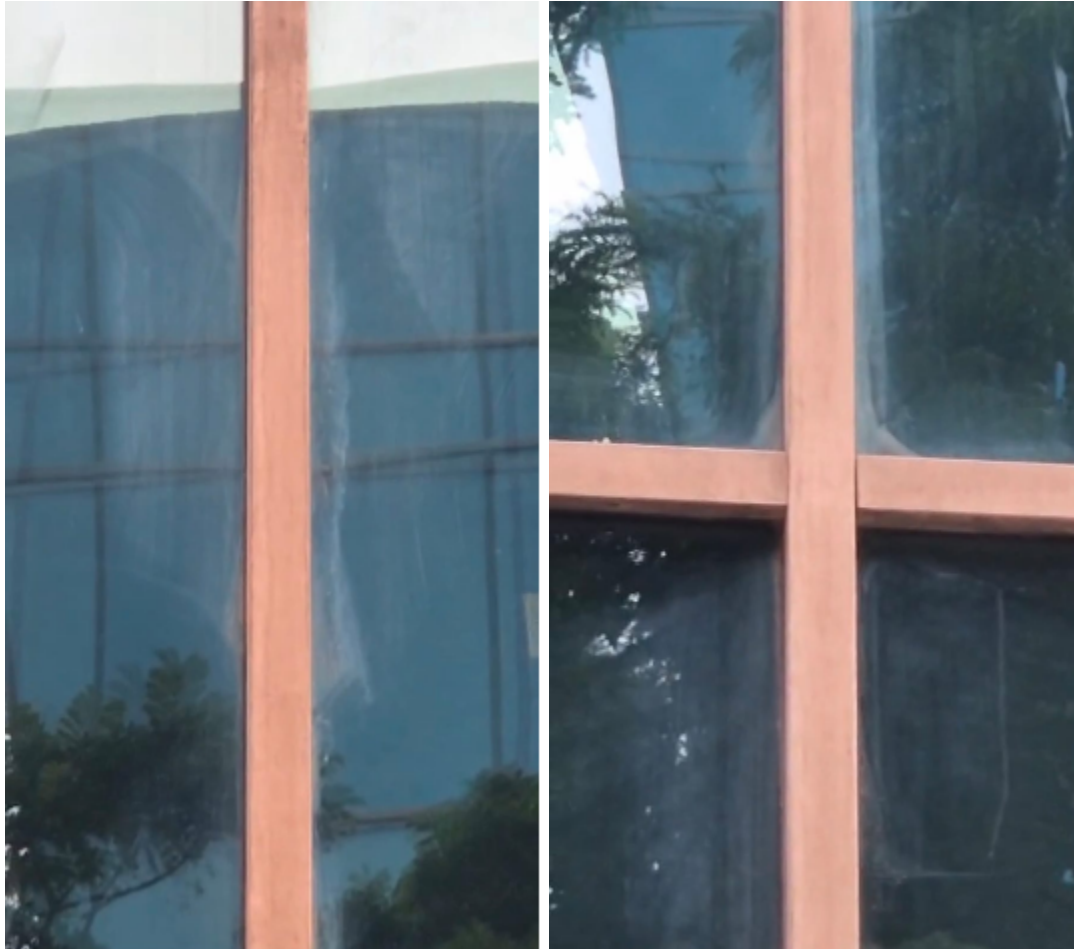
Insufficient rinsing was performed.

Microscopic analyses detected soap residues, mineral deposits, and streak formations on the surface. This indicates that adequate rinsing with clean water was not carried out after cleaning. As a result, drying marks and chemical stains formed on the glass. The aluminium trims and edges were also found to be inadequately cleaned.
